Shearographic Non-Destructive Evaluation
of the
Space Shuttle

Christopher K. Davis, NASA
Jeffery A. Hooker, INET
Stephen M. Simmons, INET
Kenneth E. Tenbusch, NASA

John F. Kennedy Space Center, Florida

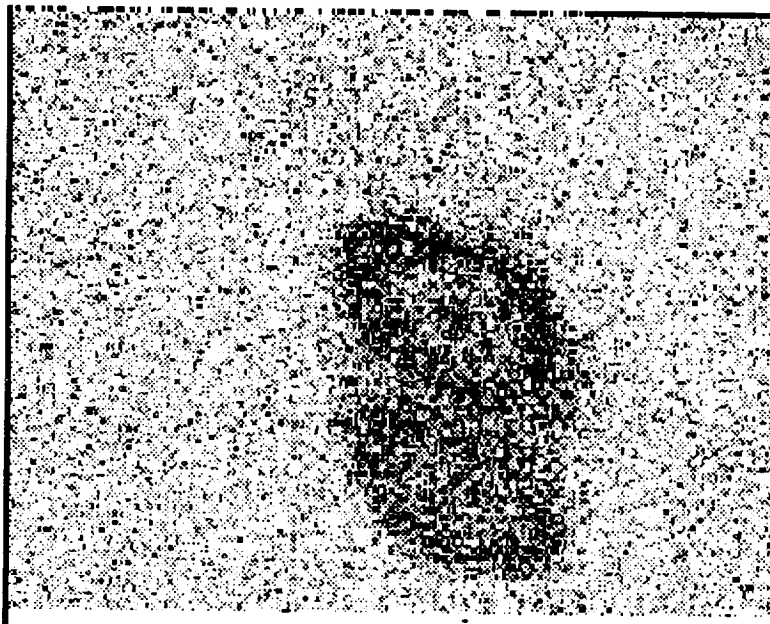
Defect #	Width (inch)	Circumferential Length (degrees)	Notes
1	0.75	20	at joint where honeycomb ends
2	4.0	20	suspect honeycomb to graphite-epoxy debond
3	4.0	320	at joint where honeycomb ends
4	2.0	150	at joint where honeycomb ends
5	2.0	145	at joint where honeycomb ends

Post-test image enhancement improves the quality of the image. FIGURE 3 below is a shearogram of Debond 1 described above. As an option, Pseudocoloring can improve the identification of the debond.

FIGURE 3: An image enhanced shearogram of Defect 1 found on the RMS s/n 201

A ten flight interval inspection of this honeycomb was rescinded by the Design Center when no NDI method was available to inspect this area of the RMS. Though shearography is not a certified inspection procedure, system engineers will use the results to determine the integrity of the honeycomb. These known debonds are not considered mission threatening, nor even structurally significant, at this time. Until the Design Center develops accept/reject criteria, shearography will inspect all RMS on a ten flight interval to monitor/detect any debonds.
